Retroreflective Airfield Markings, E	Evaluation of		Not Applicable All travel costs for Phase I funded by HQ SAC
AUTHO: (8)			ing size
Mr Michael D. Ates			
Lt Col George E. Walrond, P.E.	(S) AND ADDRESS(ES)		8. PERFORMING ORGANIZATION REPORT NUMBER
HQ Air Force Civil Engineer Su 139 Barnes Drive Suite 1 Tyndall AFB FL 32403-5319	pport Agency		
CONTRACTOR ACTOR	A NAME ST AND ADDRESS	S(ES)	10. SPONSORING MONITORING AGENCY REPORT NUMBER
Same as 7			Not Applicable
the second secon	Anna - d f Call Sphares and Judgment Call Sphares and Cal		
Not Applicable			
and the second s	And the second s		1 126 DISTRIBUTION CODE
Distribution Unlimited Appro-			
			:
		المراجعة ال	The house dest to the same of

This report provides details on two tests performed to determine if 1.5 Index of Refraction (IOR) glass beads are suitable retroreflective material for USAF airfield markings. The tests were done at Ellsworth AFB SD from 28 Sep 91 through 9 Jun 92 and at Tyndall AFB FL from 12 Dec 93 through 24 March 95. During the first phase of the project, two taxiway centerline stripes, separated by a six-inch gap were applied on the primary aircraft taxi route at Ellsworth AFB SD.. Each was reflectorized

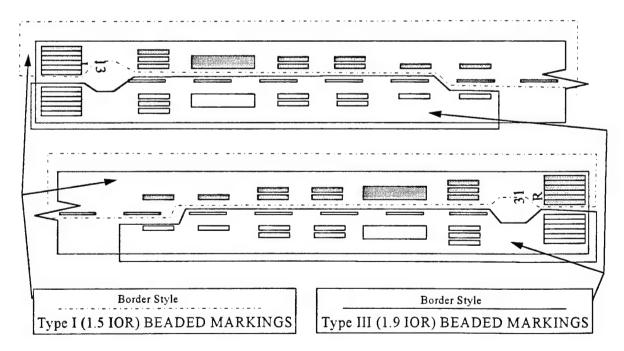
Figure 4

- b. The specific areas to be marked with each different type beads were:
- i. Type I (1.5 IOR) beads; all threshold, touchdown zone, and fixed distance markings to the left of centerline on runway 13L (north side) for the entire length of the runway, and all centerline stripes from the 7,000 feet Runway Distance Marker (distance remaining) to the 3,000 feet Runway Distance Marker (see Figure 4).

- ii. Type III (1.9 IOR) beads; all threshold, touchdown zone, and fixed distance markings to the left of centerline on runway 31R (south side) for the entire length of the runway, and the first and last 3,000 feet of centerline stripes for both approach headings (see Figure 4).

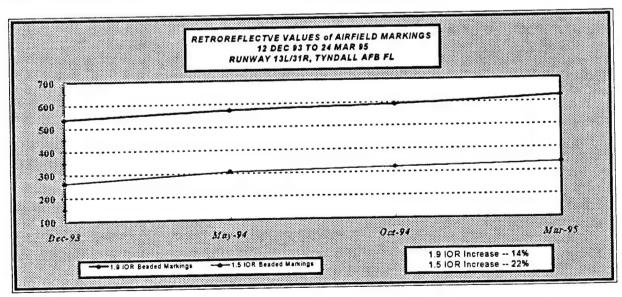
Figure 5

- 2 At this point in the evaluation, the average retroreflectivity of the 1.5 IOR markings had increased approximately 22 percent from the initial value established by the readings taken on 28 Dec 93. The retroreflectivity of the 1.9 IOR markings had also increased, but only about 14 percent from the initial value established on 12 Dec 93 (see Figure 5).

- a. We believe the reason the retroreflectivity of the 1.9 IOR beaded markings did not increase as much as the 1.5 IOR beaded markings is the 1.9 IOR beads are not as durable as the 1.5 IOR beads<sup>18</sup>.

- b. Minor damage to the inner edges (approximately two feet) of the touchdown zone and fixed distance markings occurred during a construction project to replace the slabs on the outside edge of the runway keel. The damage was caused either by the slurry spill-over common during the pouring process, or from the curing compound used. The damage occurred during the closure from 1 May 94 to 31 Jul 94. This condition was noted while performing a visual inspection prior to taking the retroreflective readings on 27 Oct 94. To prevent this condition form impacting the test, the damaged areas were avoided by relocating the instrument approximately four feet inboard form the inner edge of the markings while taking readings.
